MARE BROOK

BASELINE & BEST MANAGEMENT PRACTICES REPORT

DECEMBER 2016

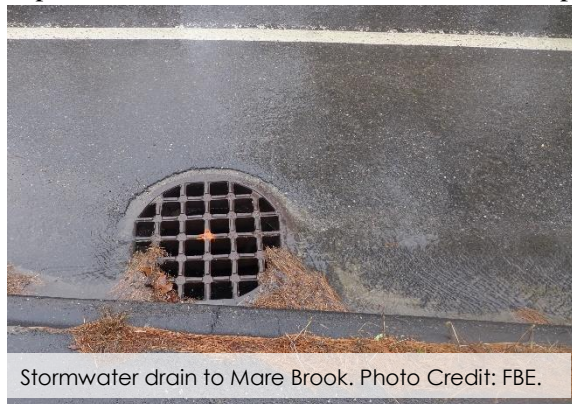
Stormwater drain to Mare Brook. Photo Credit: FBE.

IMPERVIOUS COVER (IC) such as parking lots, roofs, and sidewalks, results in runoff into the stream. Stormwater carrying dirt, metals, and other pollutants is conveyed directly from IC to the stream with minimal pre-treatment, causing increased erosion, sedimentation, increased temperature, and habitat degradation in the stream (CWP 2003).

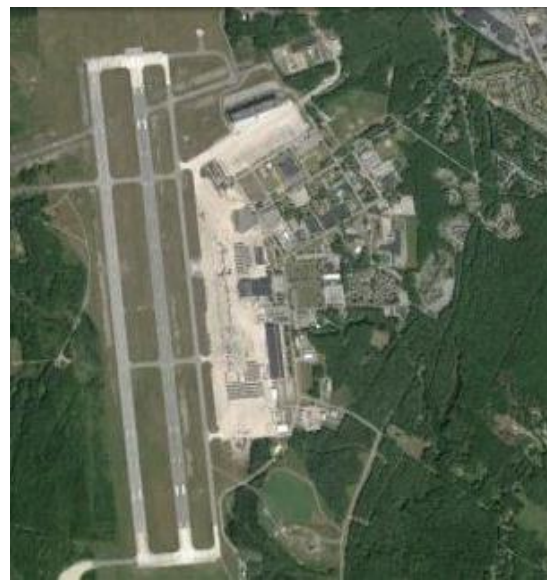
Aerial examples of IC distribution in the Mare Brook watershed. Residential Development (left) and the Brunswick Executive Airport (right).

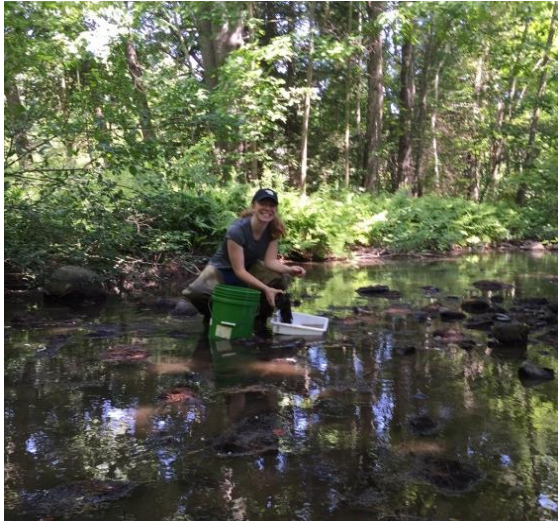
Bowdoin college intern collecting mayflies for the 2016 study. Photo Credit: Maine DEP.

stream water to flow freely through the chamber (Figs. 2.1 and 2.2). Enclosures were deployed at two sites, one near Richards Drive and one below Purinton Crossing on Merriconeag Stream. Additionally, enclosures were deployed at a reference stream in Bowdoin (East Branch Cathance River) that is geographically close to Mare Brook and also meets Class B aquatic life use standards. Five enclosures were deployed for seven days (August 5 – August 12) at each site and were stocked with ten mayflies each (Genus: *MacCaffertium*) from Douglas Brook in Gorham, Maine. Enclosures on Merriconeag Stream contained no live mayflies and there was a 28% recovery of mayfly bodies.

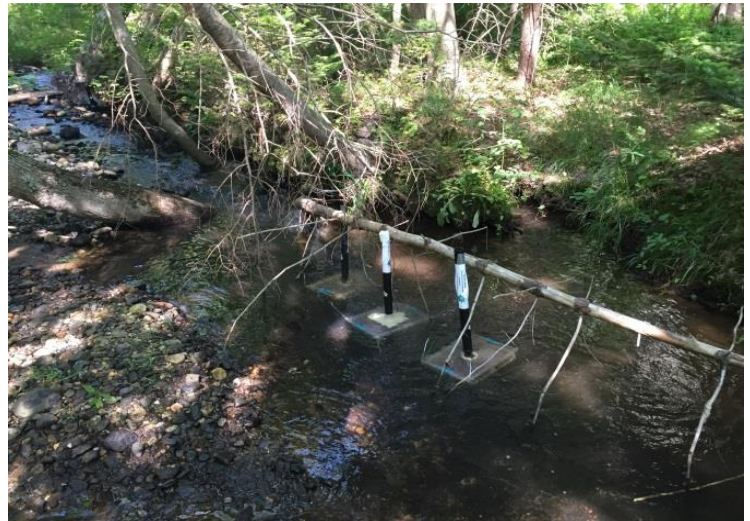
An example of the macroinvertebrate enclosures on Mare Brook. Photo Credit: Maine DEP.

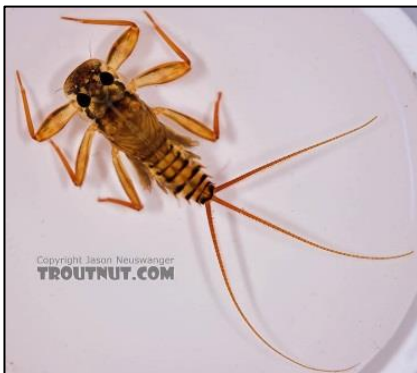
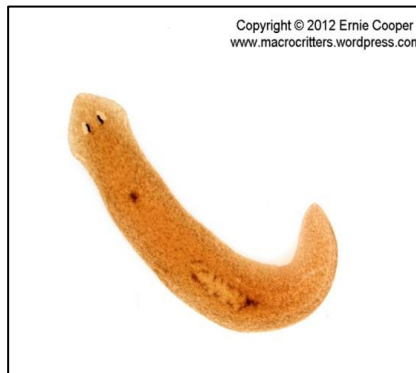
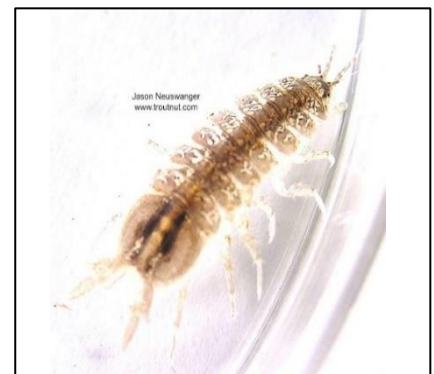
(Left) Mayfly (genus *MacCaffertium*) used in this study; (middle) Tubellaria flatworms found in Merriconeag Stream, and (right) Isopoda found in Mare Brook. Both the flatworms and isopoda were found to be predating on the mayflies. Photos from Maine DEP summary report

Presence of Planarian flatworms suggests predation could have contributed to mayfly mortality at this site. Richards Drive saw a 36.7% survival rate with 82.2% of mayflies recovered. Lack of dead bodies suggests scavenging by isopods. Unfortunately, there was no survival in the reference enclosures on the Cathance River. Mayfly bodies were recovered so it is suspected that low dissolved oxygen levels (<2 mg/L) were the cause of mortality. As a result, additional research is needed to make any conclusions from this study.

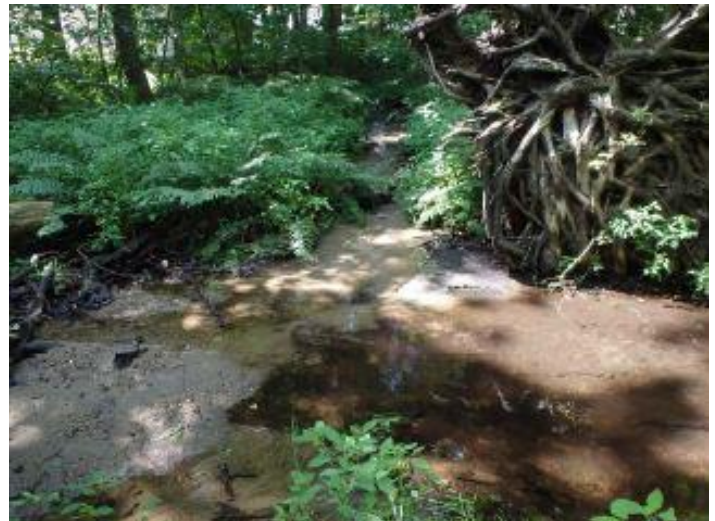
An example of excessive sediment supply in Mare Brook. Photo Credit: Stantec.

The two unstable reaches were Reach 1 (Baribeau Drive to Barrows Street) and Reach 9 (Brunswick Executive Airport to Major Pope Avenue), both experiencing excessive sediment loading and channel alteration. The two reaches along Merriconeag Stream were both rated as “stable”. Dramatic increases in sediment load were noted at the outlet of the runway culvert.

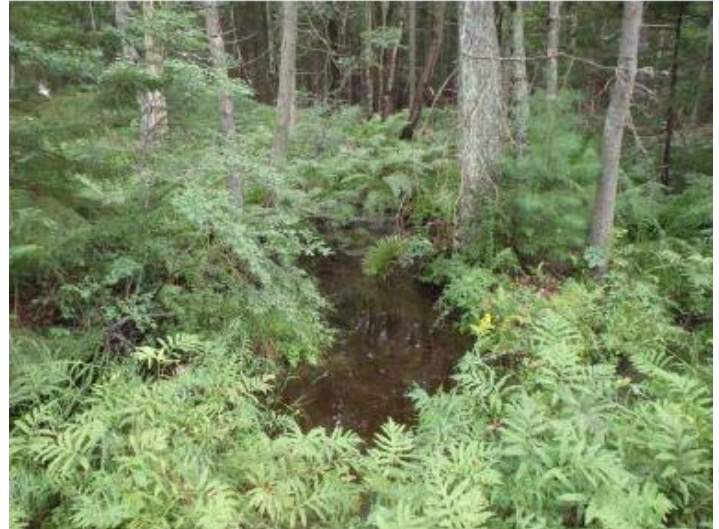
A potential vernal pool (PVP) identified by Stantec downstream of Major Pope Road.
Photo Credit: Stantec.

The State of Maine defines Vernal Pools as “shallow depressions that usually contain water for only part of the year”.

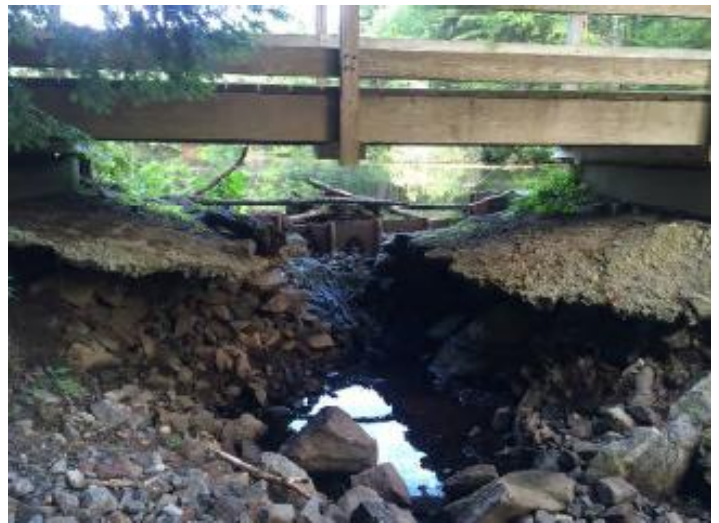
The Coffin Pond Spillway which was rated as “Not Passable” during the Fish Passage Assessment. Photo Credit: Stantec.

Finally, Stantec also completed a fish passage assessment evaluating all stream crossings along Mare Brook and Merriconeag Stream. It is important to note that this assessment was limited to the perspective of the target species (adult brook trout, *Salvelinus fontinalis*) and does not represent an assessment of other species or hydraulic conveyance in the stream. Six of the eleven stream crossings and Coffin Pond Dam were rated as “not passable” for upstream passage of adult brook trout. The remaining five culverts were in “good” condition. On Merriconeag Stream, the Beaver Pond Road crossing was rated as “not passable” and no passage is possible from the impoundment at Picnic Pond.

- Explore option of dam removal at Coffin Pond Dam and gauge landowner interest in the project. Alternatively, consider repairing the current dam structure.

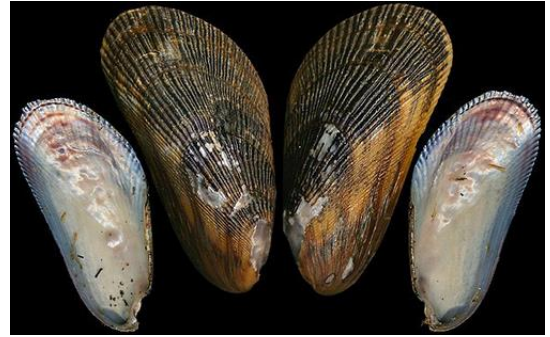
Ribbed Mussels (*Geukensia demissa*) remove toxics from the water through filter feeding. This can improve water quality but can also cause elevated toxics in the mussel tissue (Chesapeake Bay Program).

- Perform invasive species control within the stream corridor.
- Develop a strategy for assessing toxic bioaccumulation below head of tide. Consider sampling ribbed mussels (*Geukensia demissa*), benthic worms, and or predator species.

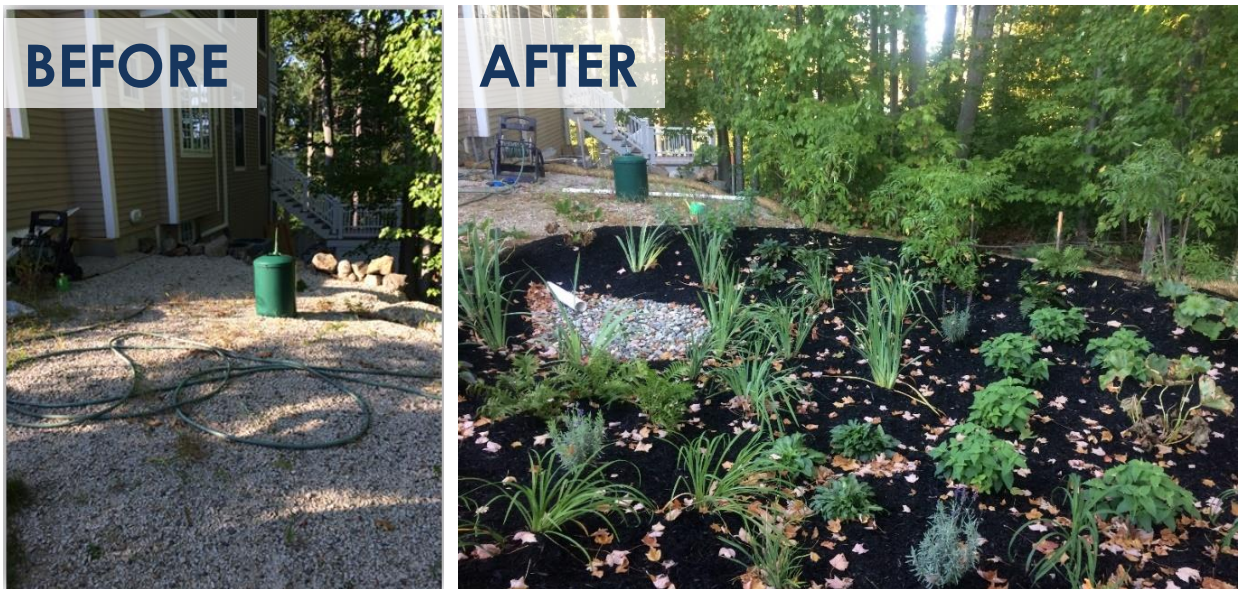
An example of a rain garden implemented on a residential property in Kittery, ME, before implementation (left) and after (right). Photo Credit: FBE

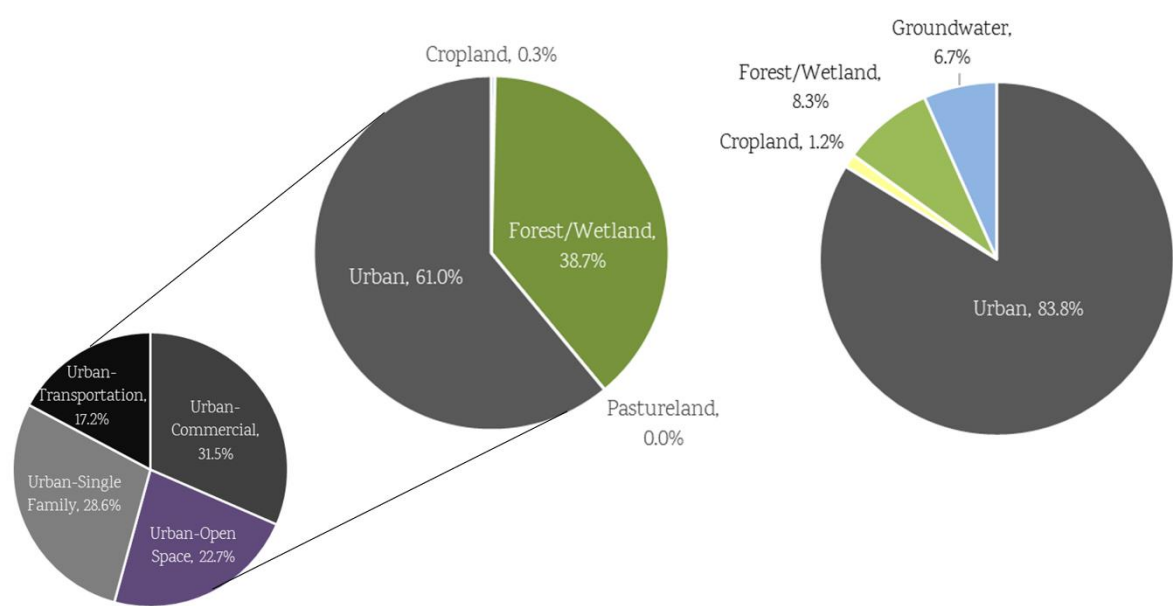
FIGURE A.1. Percent area coverage of STEPL land use categories in the Mare Brook watershed (left). Percent of total annual phosphorus load by STEPL land use category (right).

commercial (includes high/medium intensity residential development), open space, and single family residential. The model estimated that 83.8% and 1.2% of the phosphorus load to Mare Brook is coming from urban and agricultural land uses, respectively; this contrasts with forest/wetland areas that make up 38.7% of the watershed, but only contribute 8.3% of the phosphorus load to Mare Brook (Table 2.3). Groundwater contributes 6.7% and is based solely on natural soil conditions (not human-derived pollutants in groundwater).
